Propulsion Shaftline Bearing and Gear Teeth Failure Investigation on the “C” Class British Columbia Ferries

ABSTRACT

British Columbia Ferry Services Inc. operates five “C” class passenger-car ferries that were delivered in 1976 (3 ships) and 1981 (2 ships). The vessels have a service speed of 19.0 knots, are 457 ft. long, and have a gross tonnage of 6,550 tons. They have a capacity of about 360 cars and 1,500 passengers. Their route varies from Vancouver-Vancouver Island-Sunshine Coast, with up to 9 round trips per day. The vessels have a double-ended single screw propeller configuration. Each of the controllable pitch propellers are driven by one or two diesel engines rated at 5,930 HP, through single reduction gearboxes. The two gearboxes are connected via quill shafts that are concentric with the pinion shafts. The pinion shafts are engaged via clutches at the end of each of the quill shafts. This arrangement enables one or both of the diesel engines to drive either one or both of the propellers. In 1998 a catastrophic failure occurred to the bull wheel on one vessel. The bull gear teeth broke off taking out both pinions. In 1999 the bull gear on another vessel was replaced as

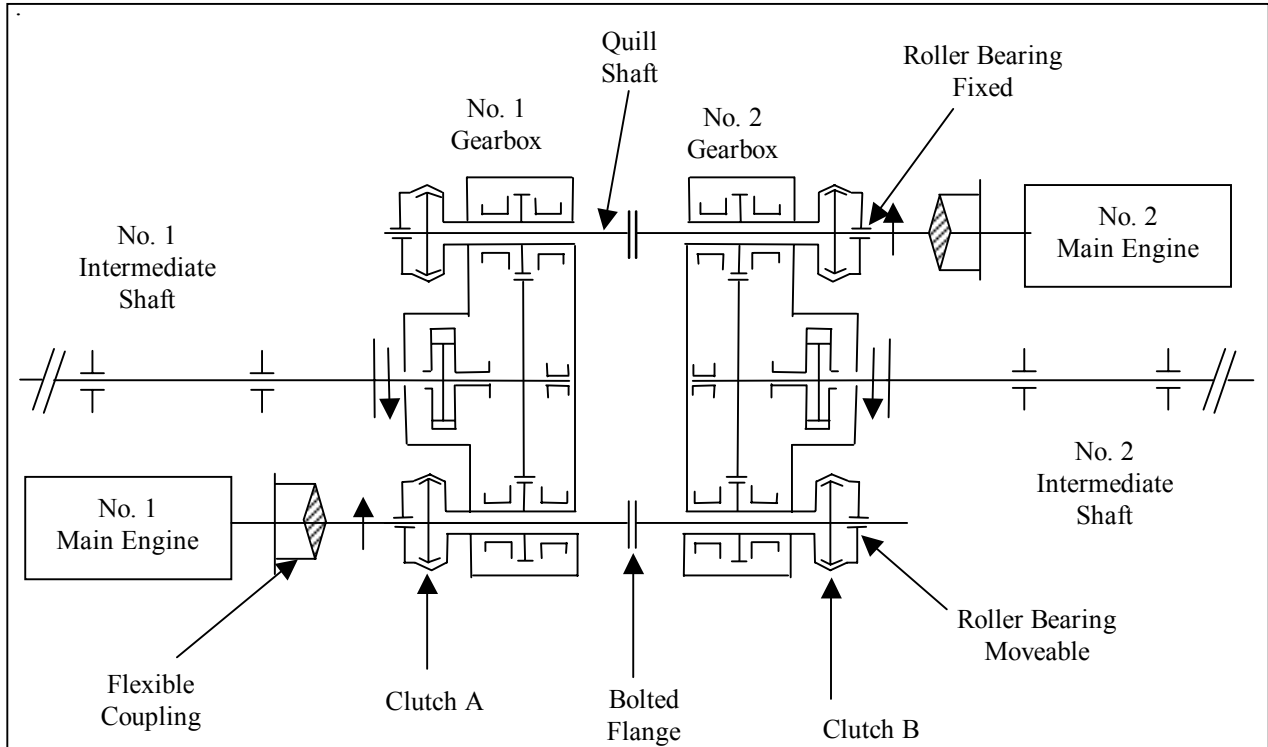
Figure 1 Propulsion System Arrangement Schematic

The “C” Class Ferries have a specialized double-ended single screw propeller configuration. Figure 1 is a schematic of the propulsion arrangement. Each of the 4 bladed controllable pitch propellers are driven by diesel engines rated at 5,930 HP at 425 RPM, through single reduction gearboxes (ratio of 2.16:1). The gearboxes are connected via quill shafts that are concentric with the pinion shafts. The pinion shafts are engaged via clutches at the end of each of the quill shafts. This arrangement enables one or both of the diesel engines to drive either one or both of the propellers. There are two normal operating modes: Mode 1: Both engines are driving one propeller, used during transit; and Mode 2: Both engines are driving both propellers, used in the harbor and during docking.

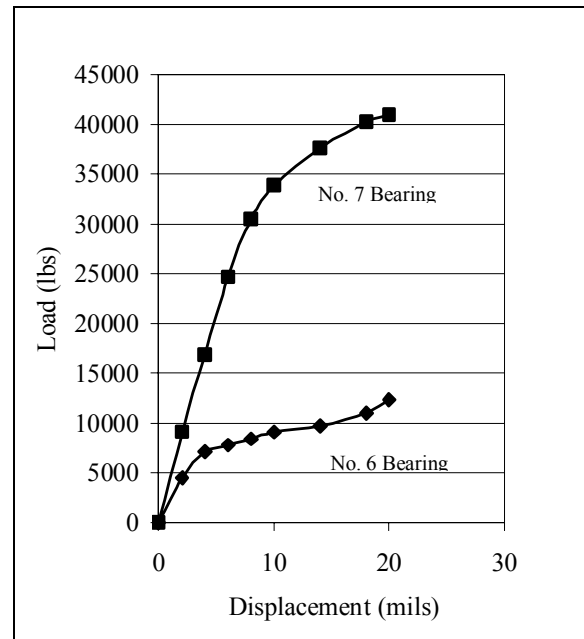
Figure 4 MV Queen of Alberni No. 1 Shaft Jack-Up Load Tests

Table 9 lists the measured bearing loads on the MV Queen of Alberni, which had a catastrophic failure of the No. 2 bull gear teeth in 1998. Table 10 lists the measured loads on the No. 1 shaft when the vessel was loaded (15 semi-trailers, 8 trucks, and 63 cars). Figure 4 shows the results of jack-up loads tests on the No. 7 and 6 bearings on the No. 1 shaft. The following conclusions are drawn from these measurements:

- The No. 7 lineshaft bearing is overloaded on the No. 1 shaftline.
- The jack-up loads test results agree with the strain gauge alignment measurements.

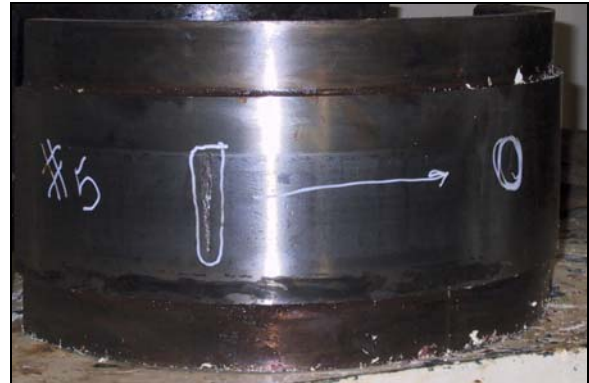
Photo 7 Damaged Race of Roller Bearing

- Lineshaft bearing No. 6 on the No. 1 shaft was top-loaded/unloaded. This condition can result in excessive lateral shaft vibrations, and is considered to be the source of failure of the No. 5 bearing on this shaftline.

Photo 7 shows a damaged race of the No. 5 intermediate shaft roller bearing (3rd aft of gear box). This damage is consistent with the measured alignment condition. Alignment measurements showed that the No.6 bearing was unloaded/top-loaded, which can result in excessive vibration of the shaftline, particularly from the No. 7 to No. 5 bearings. The realigned condition resulted in more than 8,000 lbs load on the No. 6 bearing, which should prevent such damages in the future.
