Propulsion Shaftline Bearing and Gear Teeth Failure Investigation on the “C” Class British Columbia Ferries

ABSTRACT

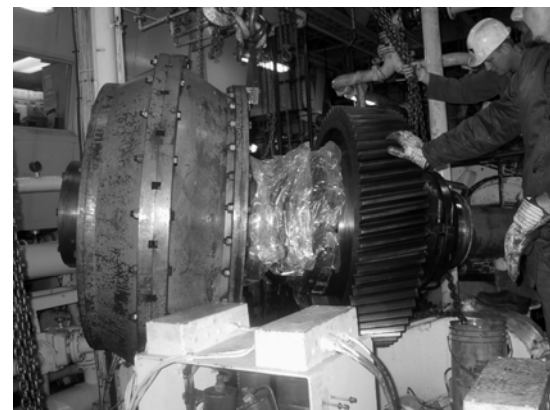
Photo 2 Installation of Pinion Shaft with Clutch

The main gear shaft is supported by two journal bearings. Each quill shaft is supported by two roller bearings located at the ends of the shafts and mounted in the clutch housings. The roller bearing nearest to the engine is a “fixed type”, and the other roller bearing outer ring is not fixed. The hollow pinion shafts are

each supported by two journal bearings located on either side of the pinion. The pinions are maintained in their axial position by “thrust stones” mounted on either side of the pinion. The thrust collar is mounted on the main gear shaft on the propeller side of the gearbox. Each propulsion shaftline is approximately 188 ft. long, and is supported by two sterntube bearings and seven lineshaft bearings. The original clutches were replaced by heavier clutches in 1991, on four of the five vessels. A picture of a gearbox is shown in Photo 1. An installation of a pinion shaft, with clutch attached, is shown in Photo 2. Figures 2 and 3 are schematics of the propulsion shafting and quill-pinon shafting arrangement, respectively. A section of the intermediate shaft is shown in Photo 3. The component parameters of the propeller, clutch, flexible coupling, and gearbox are listed in Table 1. The bearing parameters are listed in Table 2 and Table 3.

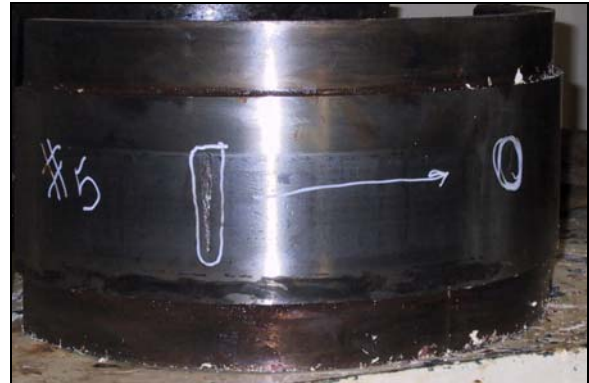
Photo 7 Damaged Race of Roller Bearing

- Lineshaft bearing No. 6 on the No. 1 shaft was top-loaded/unloaded. This condition can result in excessive lateral shaft vibrations, and is considered to be the source of failure of the No. 5 bearing on this shaftline.

Photo 7 shows a damaged race of the No. 5 intermediate shaft roller bearing (3rd aft of gear box). This damage is consistent with the measured alignment condition. Alignment measurements showed that the No.6 bearing was unloaded/top-loaded, which can result in excessive vibration of the shaftline, particularly from the No. 7 to No. 5 bearings. The realigned condition resulted in more than 8,000 lbs load on the No. 6 bearing, which should prevent such damages in the future.
