SHAFT ALIGNMENT USING STRAIN GAGES: CASE STUDIES

Two case studies are presented in which measurement and modeling programs were undertaken to assess the installed shaft alignment condition on marine vessels. One on the CCGS Earl Grey, and the other on the HMCS Huron. In both cases catastrophic damages had previously occurred to shaftline components, which were suspected to be a result of shaft mis-alignment. The damaged components were repaired, and the shaftlines were re-aligned using traditional methods (optical/laser). To assess the alignment condition of the installed shaftlines, measurements were taken by using the strain gage technique. In one case the shaft was realigned according to the strain gage measurements. Mathematical modeling was also conducted to assess the implications of the alignment measurements, and to provide the means to estimate the offsets of the installed bearings from their prescribed positions.

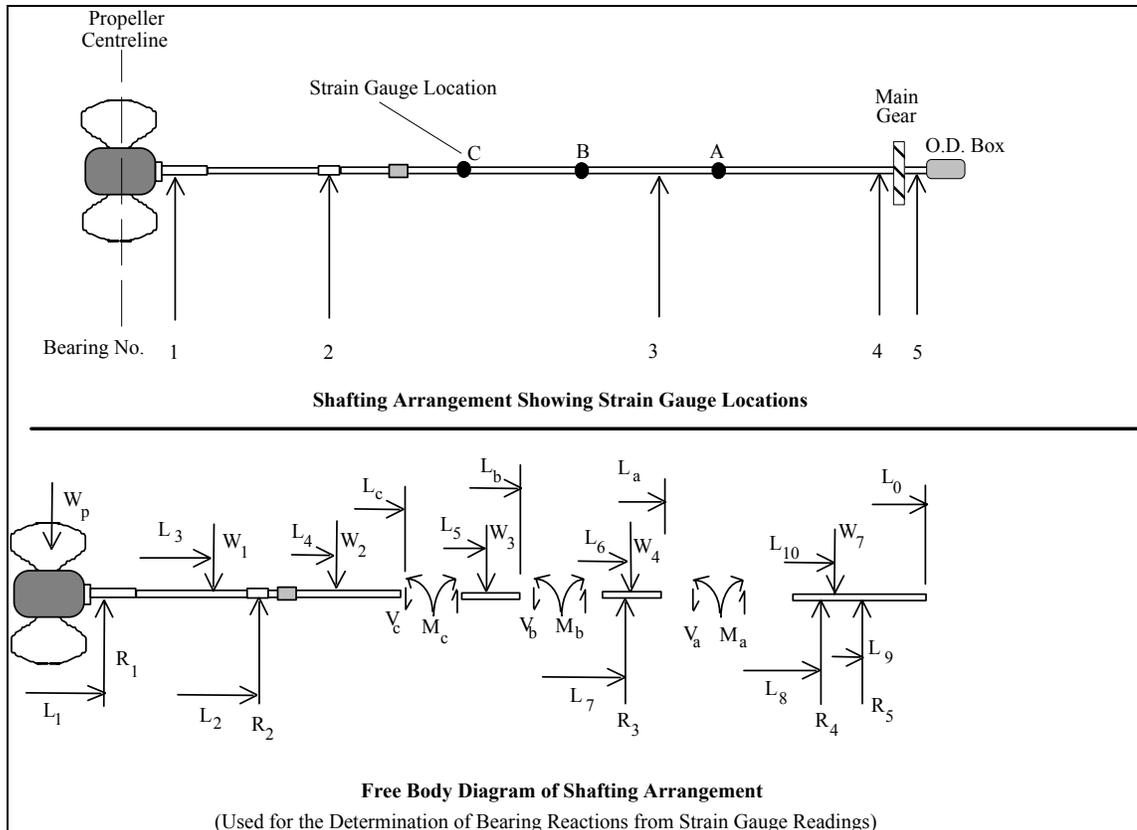
Figure 1 Shaftline Arrangement Showing Strain Gages and Free Body Diagrams:
CCGS Earl Grey

Each shaftline of the CCGS Earl Grey has 5 bearings. Therefore, an additional 3 data points must be known for the shaft alignment to be determined. Strain gages were installed at the break points indicated in the free body diagrams of the shaftline shown in Figure 1.

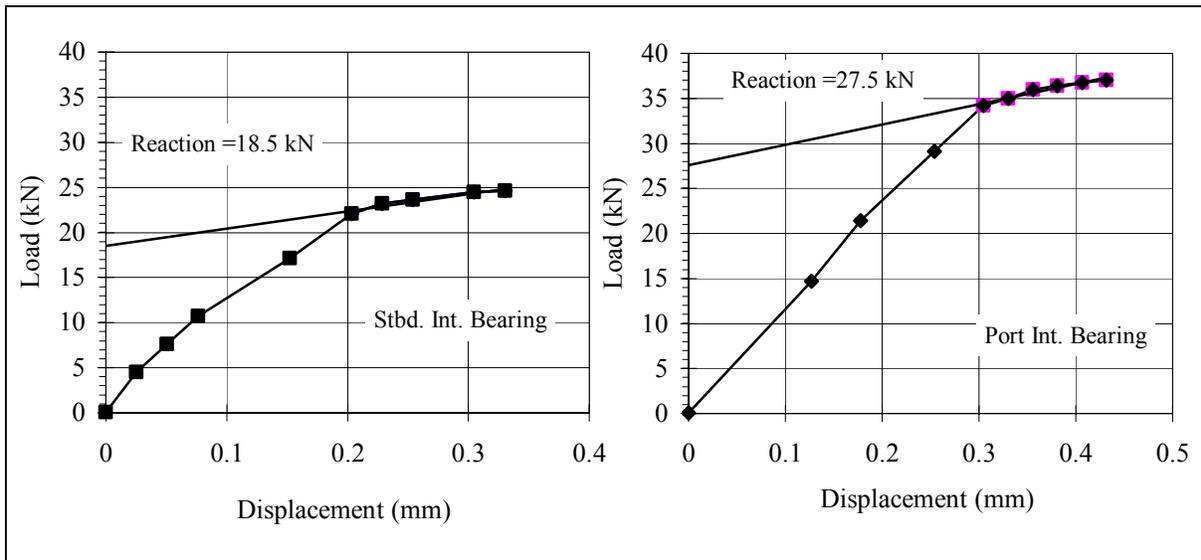
Figure 2 Jack-up Test Results

Table 1 presents the vertical bearing reactions for the measured, the estimated hot running, and the prescribed alignment condition. The results of the jack-up tests on the intermediate bearing are also listed in Table 1, and the data is plotted in Figure 2. The jack-up test results agreed well with those from the strain gage based measurements. Both measurement techniques indicated that the starboard shaft intermediate bearing reaction was significantly less than that for the prescribed condition. The reactions for the hot running condition (Gear Lube Oil T=50°C)

- The measured bearing reactions on the port shaft were in close agreement to the prescribed condition.
- The jack-up test results on the intermediate bearing agreed well with those based upon the strain gage based measurements.

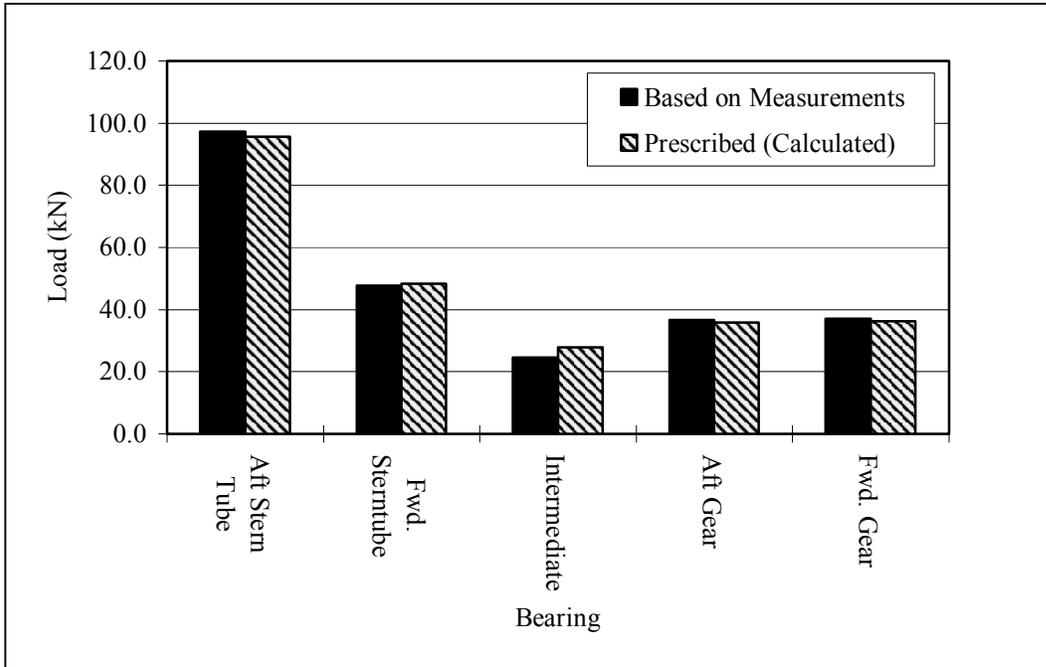
Figure 3 Port Shaft Bearing Reactions
(both inboard and outboard engines developing full power with zero power take-off)

Figures 3 and 4 illustrate the vertical bearing reactions for the hot running condition. The bearing reactions on the port shaft were in close agreement to the prescribed condition. However, the starboard intermediate bearing reaction was 60% (11.2 kN) less than the prescribed value, and the differential gear bearing reaction was 9.5 kN, which was very close to the maximum allowable of 11 kN. An analysis was conducted to determine a simple solution to resolve these discrepancies. It was determined that raising the intermediate bearing by 0.20 mm from its present position would result in relatively equal gear bearing reactions, and a 2.2 kN increase in the intermediate bearing reaction. Table 2 lists the reactions for this solution, and Figure 5 provides an illustration. It was

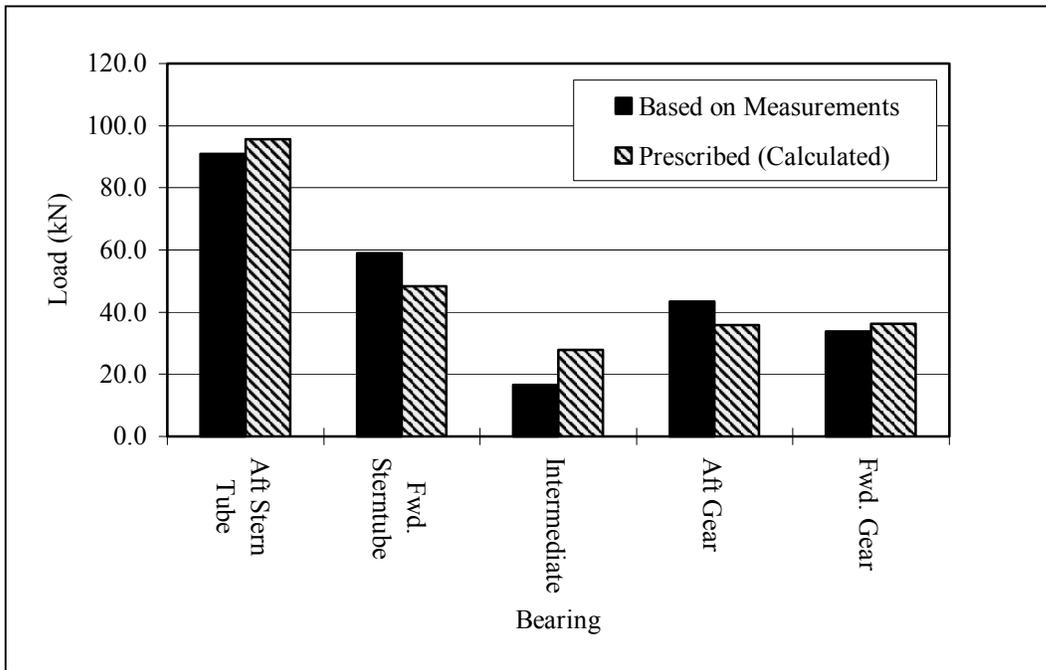
Figure 4 Starboard Shaft Bearing Reactions
(both inboard and outboard engines developing full power with zero power take-off)

- Both measurement techniques indicated that the starboard shaft intermediate bearing reaction was significantly less than that prescribed.
- In the hot running condition, with both engines on, the starboard intermediate bearing reaction was computed to be 60% less than the prescribed value. The differential gear bearing reaction was computed to be 9.5 kN, which is very close to the maximum allowable of 11 kN.

- With only the inboard engine on-line, the measurements indicated that the starboard shaft differential gear reaction would be 15.8 kN, which considerably exceeds the 11 kN design limit.

recommended that the intermediate bearing be raised 0.20 mm.

- It was determined that a satisfactory alignment condition would result by raising the starboard intermediate bearing by 0.20 mm from its present position.

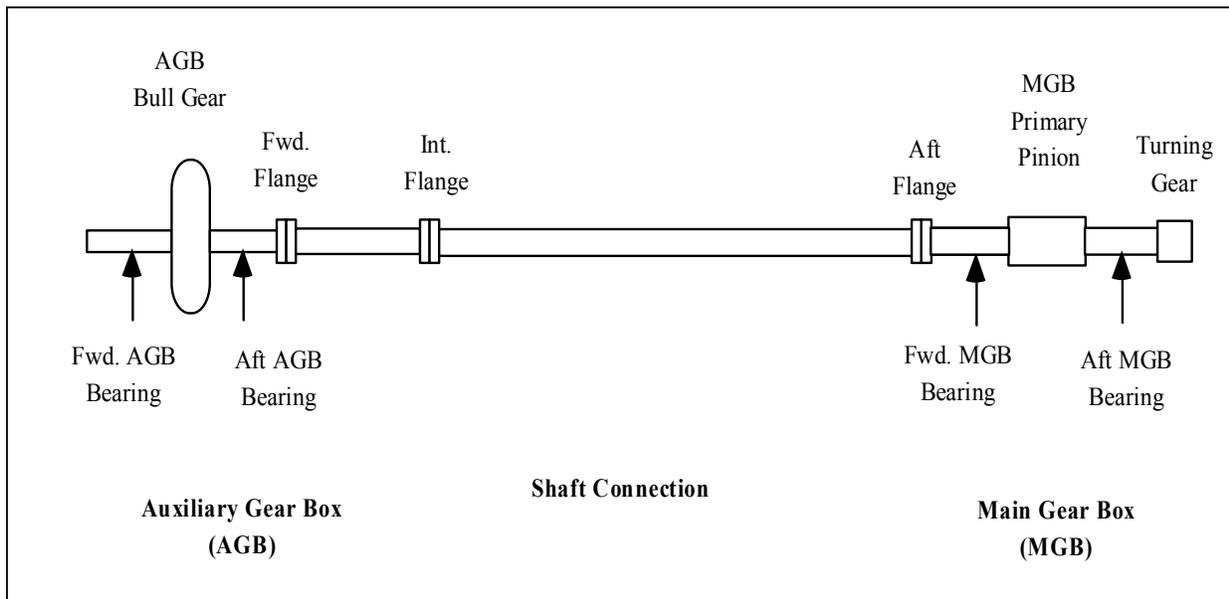
Figure 6 Schematic of Shaftline

The auxiliary gearbox output shaft is supported by four bearings, two in the auxiliary gearbox (AGB) and two in the main gearbox (MGB). The bull gear of the AGB is located between the two AGB bearings, and a primary pinion of the MGB is between the two MGB bearings. The shaft is approximately 2.9 m long. The shaft section between the AGB and MGB has an outside diameter of 0.130 m and an inside diameter of 0.116 m, and is 42NiCrMo₆ steel. There are three bolted flanged connections. Figure 6 provides a schematic of the shaftline.

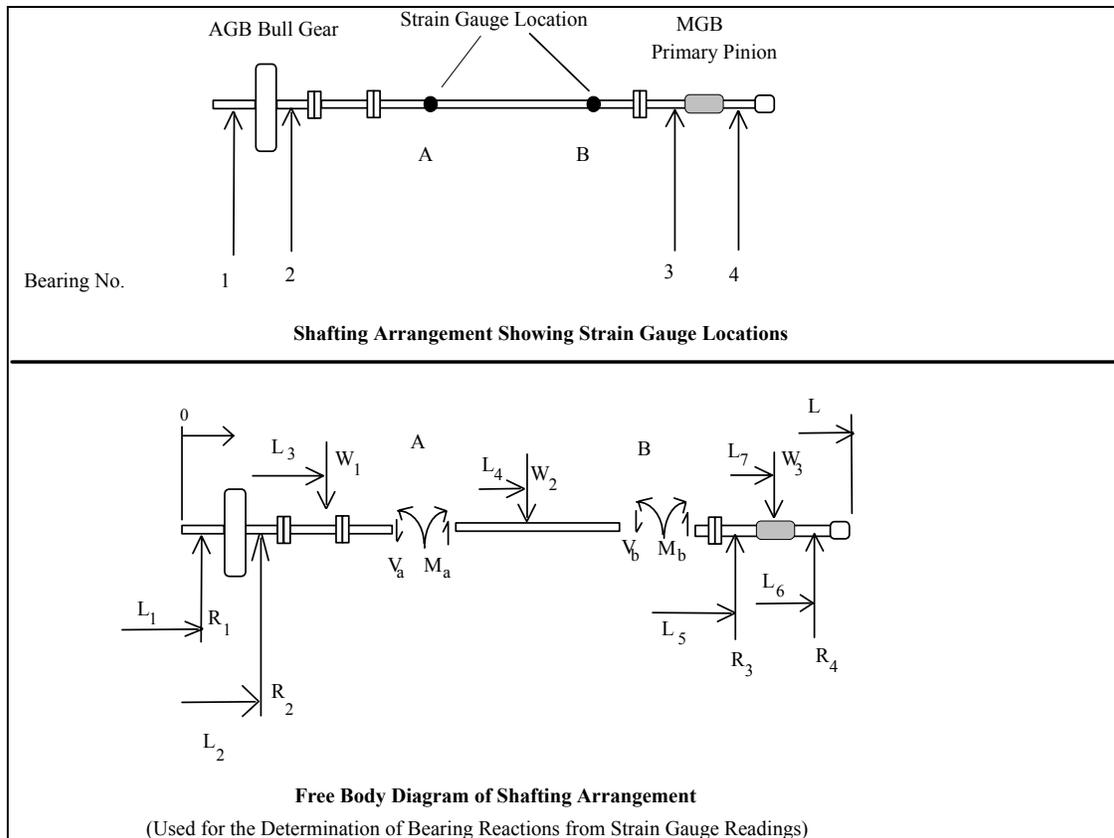
Figure 7 Shaftline Arrangement Showing Strain Gages and Free Body Diagrams

The Auxiliary Gearbox (AGB) shaftline of the HMCS Huron has 4 bearings. Therefore, an additional 2 data points must be known for the shaft alignment to be determined. Strain gages were installed at the break points indicated in the free body diagrams of the shaftline shown in Figure 7. Measurements were taken of both the starboard and port side shaftlines.

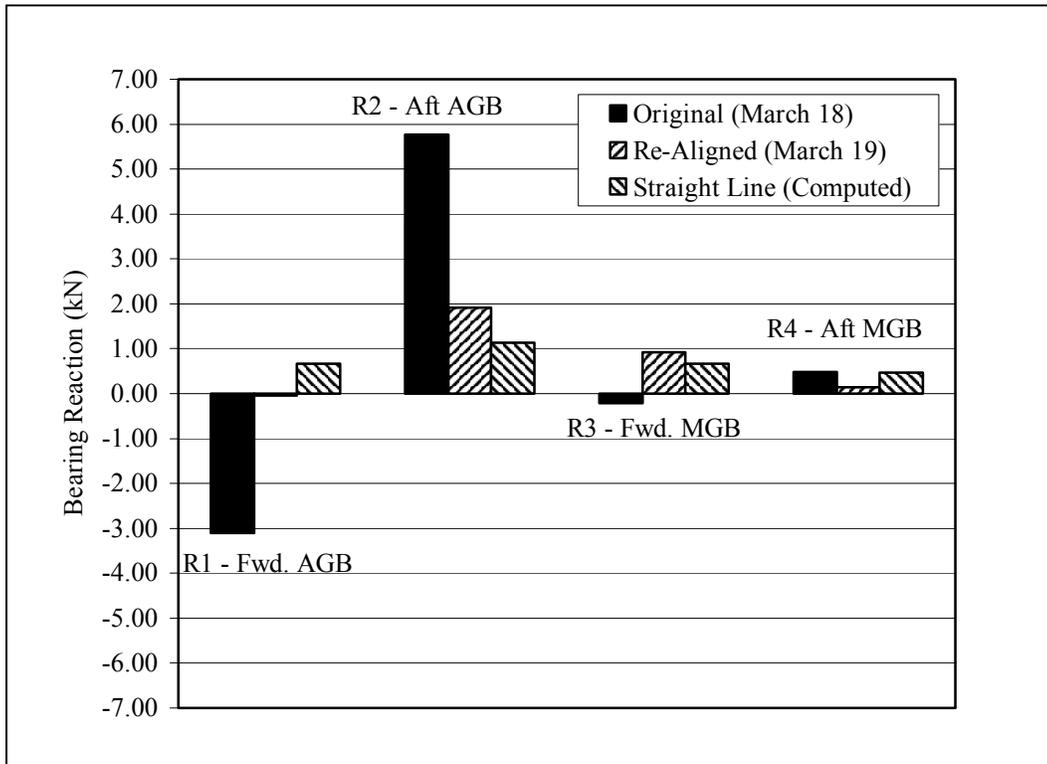
Figure 8 Port Shaft Vertical Bearing Reactions

Table 7 and 8 present the measured horizontal and vertical bearing reactions respectively. Figure 8 presents the port shaft vertical bearing reactions for each position of the AGB. The computed straight-line alignment reactions are also presented for comparison. The results indicated that under the re-aligned condition the port shaft horizontal bearing reactions are approximately zero, indicating a straight line condition. Although the forward AGB bearing is slightly unloaded, the corresponding vertical bearing reactions agree reasonably well with the straight-line condition. While in operation the pinion forces on the Bull Gear of the AGB produce a significant downward force on the AGB bearings, which ensures that these bearing are down-loaded.

It was recommended that the port side AGB be re-aligned to the MGB. However, due to the time constraints imposed by the HMCS Huron's schedule, the more traditional optical alignment method was not feasible. Therefore, the re-alignment was conducted with the aid of the strain gage readings, because measurements could be taken without removal of the AGB shaft. This was done by modifying the horizontal position of the AGB until the strain gage output indicated negligible horizontal bearing reactions (i.e., low output voltage). Then the vertical position of the AGB was adjusted until the strain gage readings provided similar bearing reactions to the straight-line condition. The measurements were taken during March 19, 1997, while the vessel was alongside the dock at CFB Esquimalt.

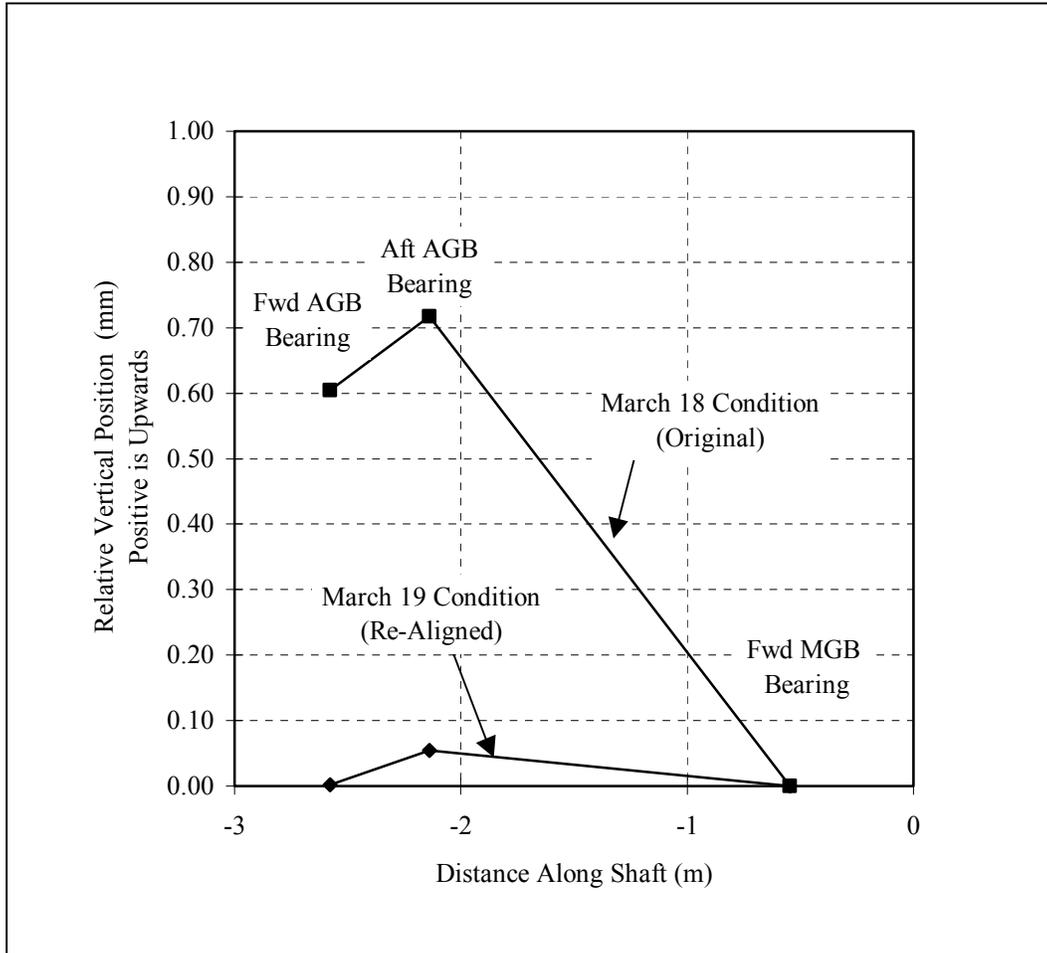
Figure 9 - Relative Vertical Position of Bearings: HMCS Huron Port AGB

The influence coefficients and bearing reactions computed from the mathematical model, and the measured bearing reactions, were used to estimate the bearing offsets from the straight-line condition (all bearing centers concentric). Figures 9 and 10 illustrate the estimated original mis-alignment condition, and the results of the re-alignment done on March 19, in

terms of relative bearing positions. After re-alignment, the aft AGB bearing center was approximately 0.08 mm (.0032”) above a line through the MGB bearing centers, and the fwd AGB bearing was on-line. All bearing centers were aligned horizontally after the re-alignment.

- The strain gage technique used for the re-alignment of the auxiliary gearbox (AGB) was very successful, and cost effective.
- After re-alignment, the measurements indicated that the port side auxiliary gearbox (AGB) was in reasonable alignment with the main gearbox, both in the vertical and horizontal directions.
- It was recommended that similar shaft alignment measurements be taken on other vessels of the same class to assess their respective alignment condition.
