## Solutions to Failures of Shaft Bearings on Vessels Fitted with Z-Drive Thrusters No. 27

**Bruce Cowper**, SNAME Member,  
LamaLo Technology Inc.

### ABSTRACT

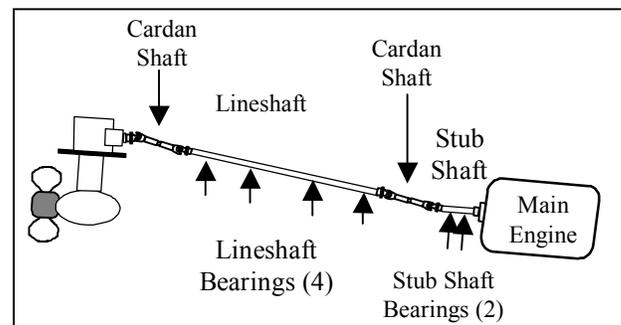
Figure 1 Schematic of Propulsion Shaftline

A typical shaftline arrangement has Cardan shafts with universal joints that are used to couple the Z-Drive thruster and diesel engine to a lineshaft, as shown in

Figure 1. Roller element bearings are used to support the lineshaft. A roller bearing with axial load capability is fitted to the lineshaft and stub shaft. Systems with three to seven lineshaft bearings were investigated, some fitted with stub shafts, some without. Those with stub shafts have two bearings that are used to resist the bending moments applied by the Cardan Shaft [1]. Systems without the stub shaft have bearings that are integral to the torsional coupling. Photos 1 and 2 illustrate a damaged lineshaft bearing.

The following example alignment procedure applies to a shafting system similar to that in shown in Figure 1 and in Case 3. This procedure is designed to produce the prescribed bearing offsets and loads listed in Table 10.

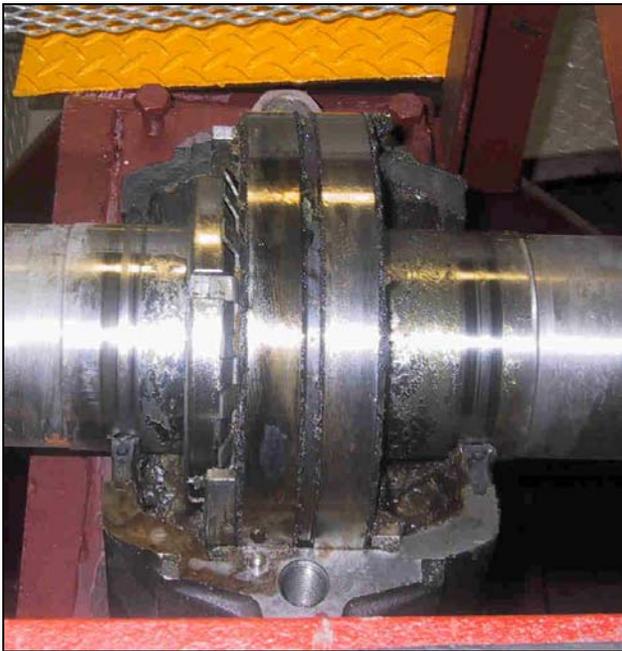
**Photo 1 Lineshaft Bearing – Bearing Cap Removed**  
(Note: Left side shows over-heating has occurred)

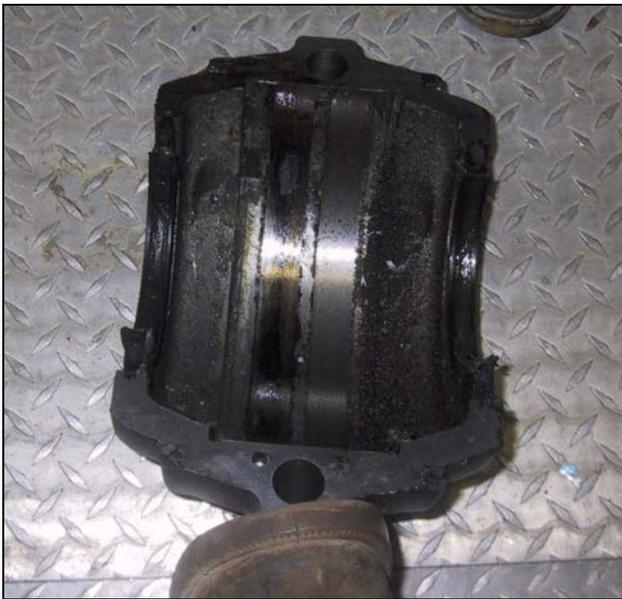
**Photo 2 Inside of Bearing Cap**

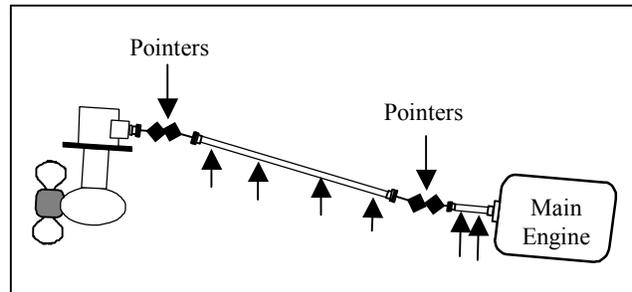
**Figure 2 Alignment of Main Engine and Z-Drive using Pointers**

Propulsion suppliers typically provide procedures that call for alignment using "pointers" mounted on the aft and forward ends of the lineshaft and the Z-Drive thruster and engine output shafts. The primary purpose of the pointers is to ensure the Cardan Shaft Yoke angles are equal. They also align the main engine with the Z-Drive, and the aft and forward most lineshaft bearings, as

shown in Figure 2. A typical tolerance for alignment of the pointers is  $\pm 1$  to 3 mm (runout). The stub shaft is aligned within the tolerances specified by the main engine and torsional coupling manufacturers, accounting for differential thermal growth. A typical allowance for the thermal growth is 0.25 mm, with an allowable radial offset of about  $\pm 0.5$  to 1.0 mm.

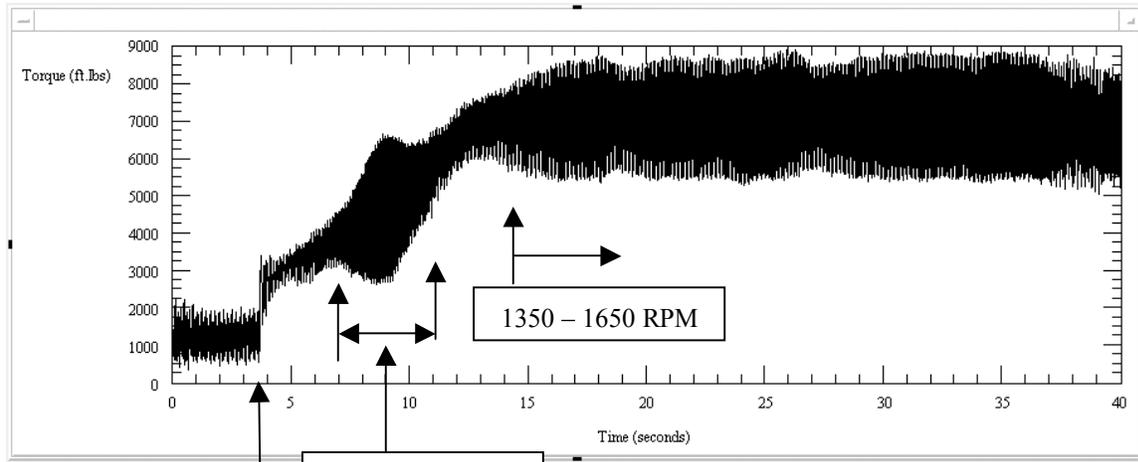
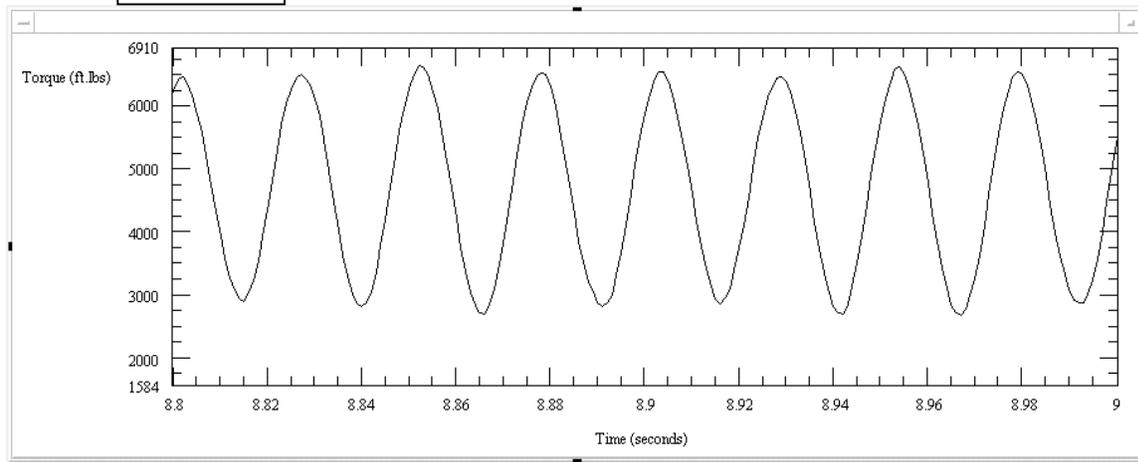
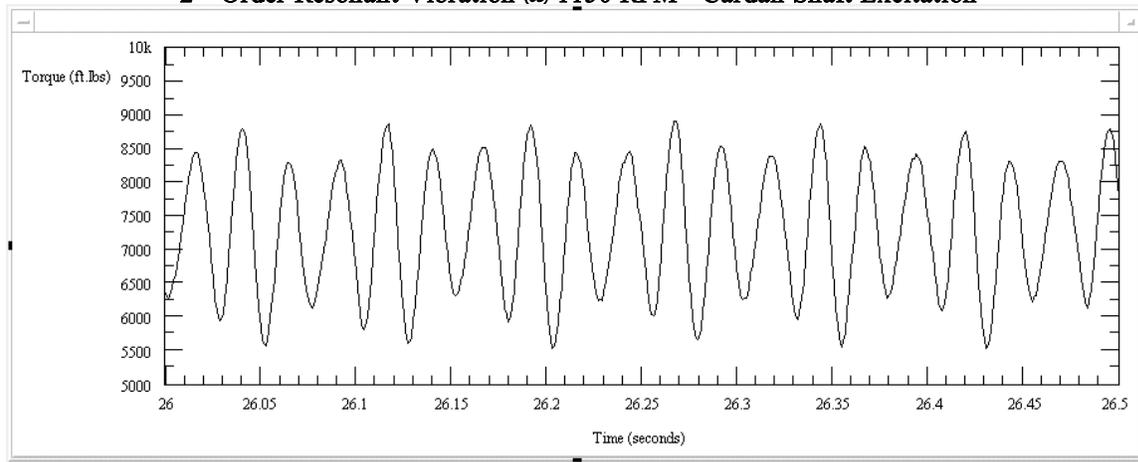
**Figure 3 Measured Resonant Torsional Shaft Vibrations during Fast Acceleration (Idle to 1650 RPM)**

Clutch -In

1050 - 1250 RPM

1350 - 1650 RPM

**2<sup>nd</sup> Order Resonant Vibration @ 1150 RPM - Cardan Shaft Excitation**

**1.5 Order Resonant Vibration @ 1650 RPM - Engine Excitation**

Note: Loud Noise Heard from 1350 to 1650 RPM

Allowable torsional alternating stress is in the range of 25 MPa (3,600 psi) [8,9,10]. Alternating shaft torque corresponding to these stresses can be as high as 80% of the maximum continuous rated torque. Since the Cardan shaft produces lateral forces on the shaftline from the applied torque [1], a more restrictive criterion is recommended. Figure 3 illustrates shaft torsional vibrations measured in the middle of a lineshaft, which were found to be excessive. Torsional natural frequencies that are equal to 1.0, 1.5, and 2.0 times the maximum rated shaft speed are recommended to be avoided. The allowable alternating torque is recommended to not exceed 25% of the full power mean torque [8].

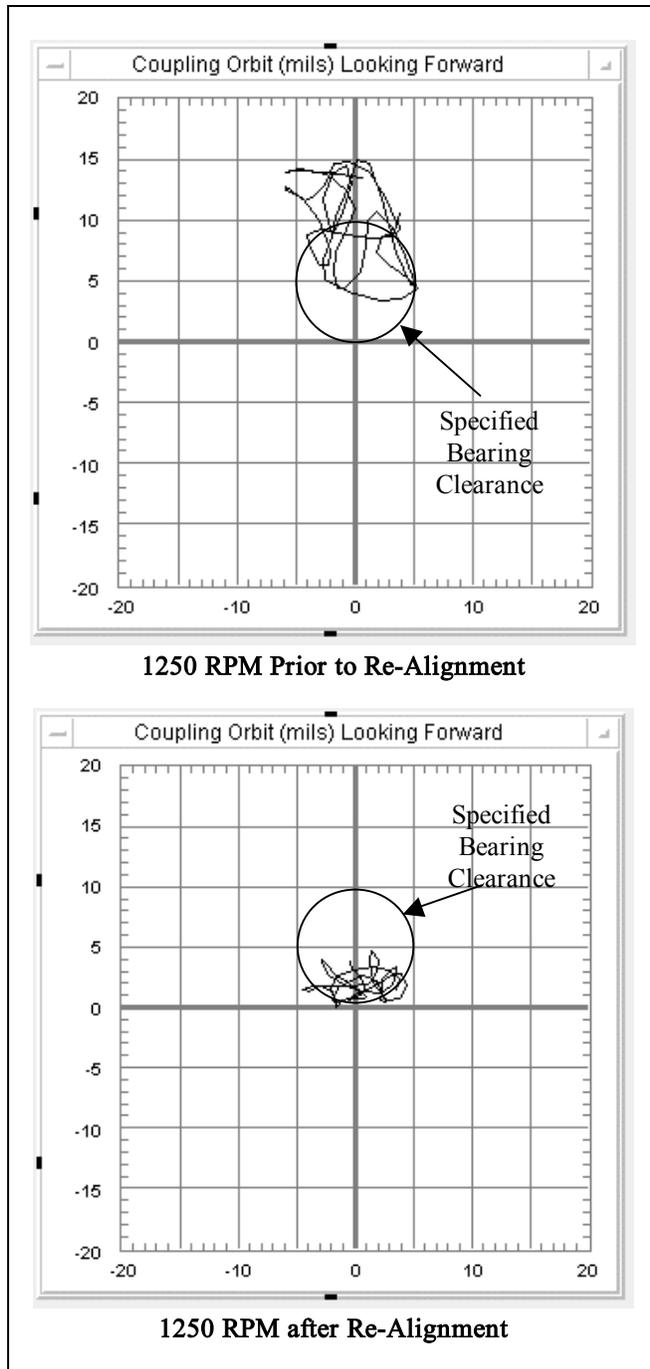
**Figure 4 Measured Shaft Orbit at of Stub Shaft**  
(Conversion Note: 1 mil = 0.001" = 0.0254 mm)

To avoid excessive lateral vibrations the first natural frequency of vibration is required to be at least 230% of the maximum rated shaft speed, because the Cardan shaft induces a dynamic bending moment on the lineshaft [8]. This moment is proportional to the shaft torque, is at a frequency equal to twice the shaft speed, and results in dynamic lateral loads (vertical and horizontal) on the lineshaft bearings [1]. These loads, and the relatively high shaft speeds, impose significant constraints on the shafting design. More bearings are typically required than conventional shafting systems to increase the lateral natural frequency to an acceptable value. This results in low loads on the bearings and a relatively stiff shafting system which require the lineshaft bearings to be positioned very accurately. Figure 4 shows the shaft orbit measured prior to and after a re-alignment of a lineshaft,

which illustrates how a mis-alignment can result in excessive lateral vibrations. The top plot in Figure 4 illustrates the shaft movement exceeding the specified bearing clearance. For the shaft systems examined, a critical shaft speed for 2<sup>nd</sup> order lateral vibrations occurs within the operating shaft speed range if one of the lineshaft bearings is removed. Therefore, resonant lateral vibrations may occur if a lineshaft bearing is unloaded.

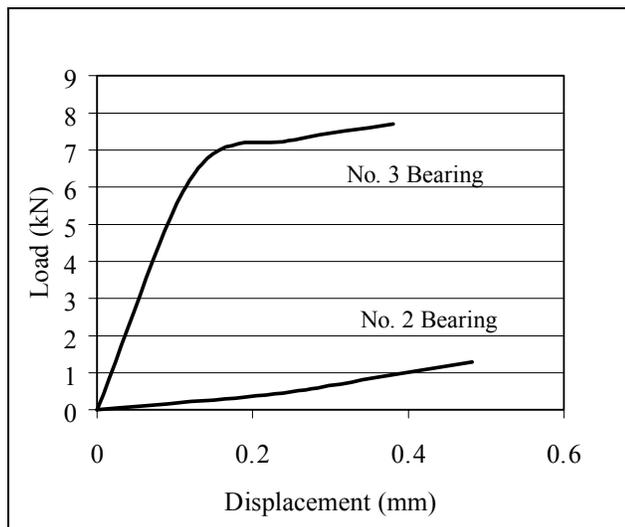
**Figure 5 Jack-Up Load Tests Port Shaft: Case 1**  
(Prior to Realignment)

A realignment of the propulsion shafts was conducted from January 14 to 15, 2002. Table 3 presents the measured bearing loads. Figure 5 shows the results of the jack-up load tests on the No. 2 and 3 port shaft bearings prior to realignment, which are similar to the strain gauge results. To obtain an acceptable alignment condition, the middle bearings on the port and starboard shaft were raised 2.2 mm and 2.8 mm, respectively. The maximum measured shaft static bending stress was reduced from 17.2 MPa to 1.2 MPa as a result of the realignment. Based upon the bearing load measurements and the influence numbers, it was estimated that the shafts were straight aligned to less than  $\pm 0.10$  mm.

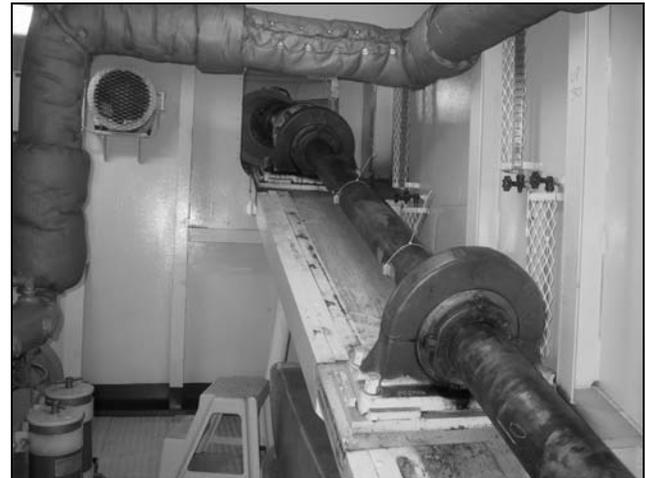
The propulsion system has two thrusters (port and starboard), each driven by a GM-EMD 16-645 E5 diesel engine, with a rating of 1604 kW (2150 HP) at 900 rpm. Each lineshaft is about 6100 mm (240") long and is supported by four roller bearings. The third bearing from the aft end is a fixed bearing, to carry axial loads from the shaftline. There is an 890 mm (35") stub shaft that connects the main engine to the lineshaft, which is supported by 2 spherical roller bearings. The aft bearing is a fixed bearing, to prevent axial movement of the stub shaft. Photo 3 shows the aft two bearings on the lineshaft.

**Photo 3 Aft Two Bearings on Lineshaft**

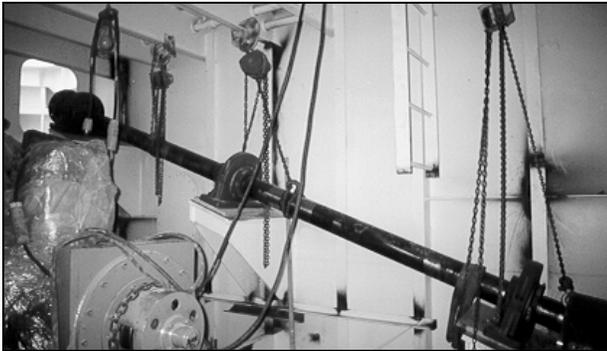
The vessel was delivered in 2000, after which excessive vibrations were observed around both shaftlines, and in particular the port shaftline from the No. 6 (aft) to No. 4 bearing. The starboard shaftline had considerable less vibration. The vibration levels on both shafts on the sister vessel were reported to be satisfactory.

In 2000 structural vibration measurements and analysis were conducted. In accordance with recommendations from previous vibration measurements and analyses (not LamaLo Technology Inc.), the bearing supports were stiffened. Additional angle bar was added to tie the bearing seatings together and steel pipes were welded from the seating to the shell plating stiffeners. Photos 4

**Photo 4 Original Bearing Supports: Case 3**

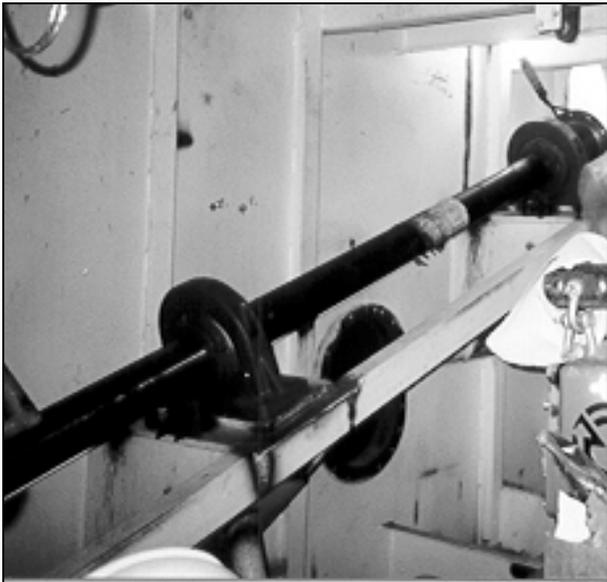
and 5 show the lineshaft and bearing seating supports prior to and after modifications, respectively. About 20 months after the modifications, the vibration levels increased again, and cracking of the welds where the added angle bar was fitted to the bearing seating occurred on a number of occasions, and the vibration levels increased.

**Photo 5 Modified Bearing Supports: Case 3**

To determine an optimum solution to the excessive vibrations, an investigation was conducted that involved a combination of theoretical modeling, design review, and on-site measurements. The installed alignment condition was measured August 5, 2002. It was found that both the port and starboard shafts were misaligned, such that the No. 5 bearing on the port shaft, and No. 4 bearing on the starboard shaft were top-loaded (numbered forward to aft). In addition, the port shaft was hogging by over 2.54 mm (0.100"), but the starboard shaft was near the straight-aligned condition. Both shafts were realigned to provide for satisfactory bearing loads on August 6, 2002. The hog of 2.54 mm was still present in the port shaft, while the starboard shaft was straight aligned. The vessel was tested and the vibration

levels were found to be satisfactory on the starboard shaft. However, the port shaft vibrations were excessive, in particular the No. 4 lineshaft bearing, which demonstrates that although the bearing loads were satisfactory the alignment condition was not. The port shaft was re-aligned to be near the straight-aligned condition on August 7, 2002 and tested that evening. All bearing temperatures and vibrations were then found to be acceptable. Table 7 lists the measured bearing loads prior to and after the realignment. The maximum measured shaft static bending stress was reduced from 18.6 MPa (2,700 psi) to 4.1 MPa (600 psi) on the starboard shaft, and from 24.4 MPa (3,450 psi) to 3.3MPa (480 psi) on the port shaft, as a result of the realignment work. The strain gauge measurements indicated that the shafts were straight-aligned to less than  $\pm 0.13$  mm ( $\pm 0.005$ " ), after the realignment.
