# Lateral Mode

## The importance of shafting vibration analyses

BY D. N. BRUCE COWPER  
AND ZAC SCHRAMM

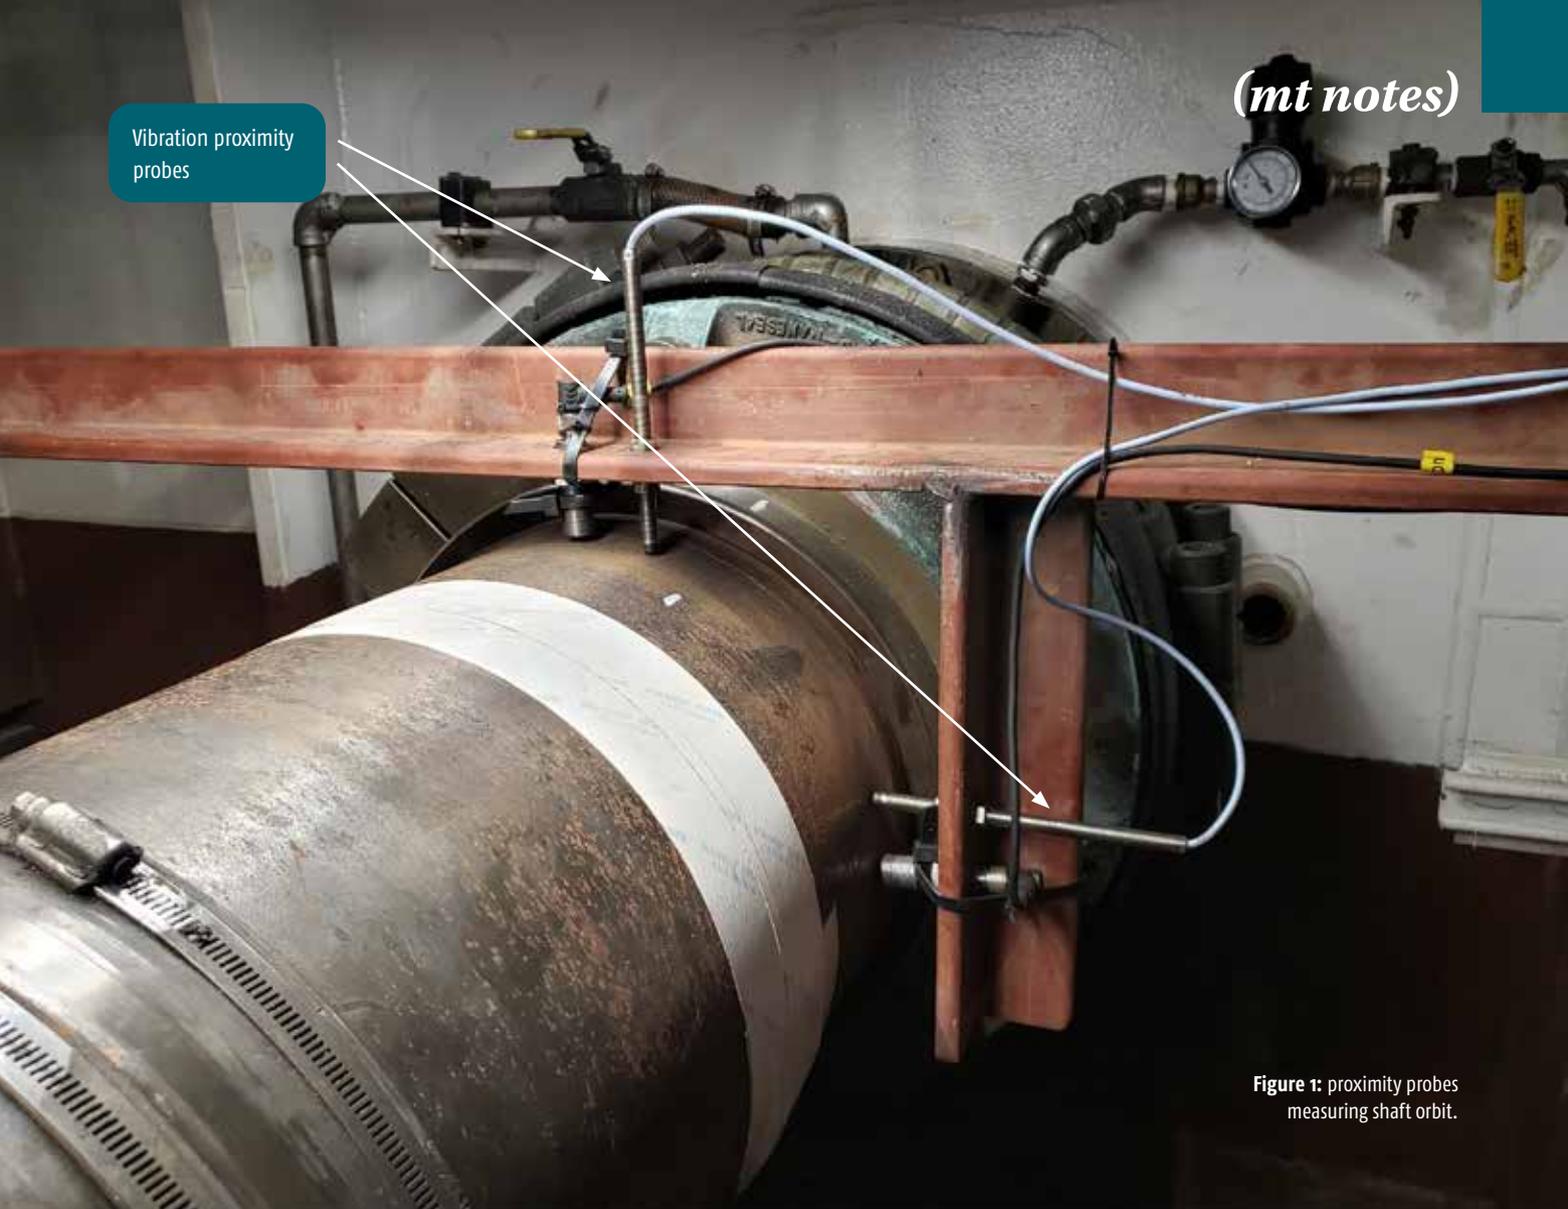
Figure 1: proximity probes measuring shaft orbit.

To further investigate, all three modes of shafting vibration were measured with proximity probes being used to describe the shaft orbit in the vertical plane. Figure 1 shows a typical arrangement for measurement of lateral vibration using proximity probes located immediately forward of the seal near the forward sterntube bearing. It was found that lateral vibrations were excessive while maneuvering and also when operating in the dynamic positioning mode. Figure 2 illustrates the measured range of shaft orbits of two vessels of the same class during turns to starboard, one of which had the forward sterntube bearing loaded and the other with it unloaded.

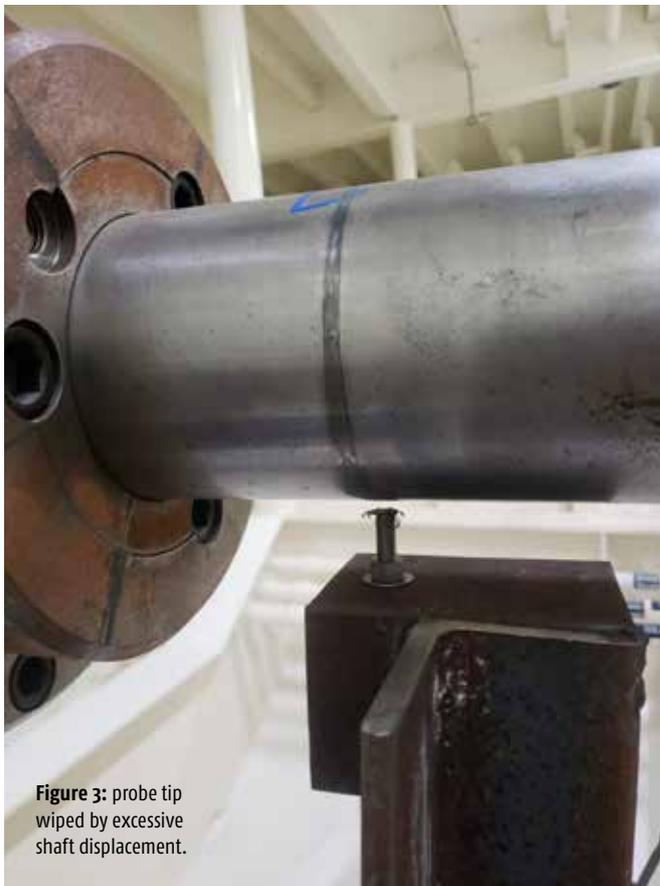
**Figure 3:** probe tip wiped by excessive shaft displacement.

During dock trials, significant excessive lateral vibrations at 1,100 RPM were found. The system was emergency stopped. The maximum vertical displacement of the shaft was approximately 7 mm based upon a damaged proximity probe, as shown in figure 3. The associated time domain plots are shown in figure 4, where shaft vertical vibrations were increasing exponentially, indicating resonance vibrations.
