# Application of the strain gauge alignment technique on slow-speed diesel propulsion shafting installations

Bruce Cowper, *LamaLo Technology Inc., Calgary, Alberta, Canada*  
Dave Rickman, *VTHalter Marine Inc., Pascagoula, Mississippi, USA*  
Dean Sahr, *Aker Philadelphia Shipyard, Philadelphia, Pennsylvania, USA*

Marine propulsion shaft alignment using the strain gauge alignment technique is becoming more common place as shipyards and owners find the technique is accurate, reliable and cost effective. There are a number of advantages of incorporating this technique on slow-speed diesel propulsion shaftlines. Accurate measurements of both the vertical and athwartships loads on the lineshaft and sterntube bearings can be obtained while the shaft is completely assembled. Direct measurement of the shear and bending moment at the thrust shaft flange can also be obtained, to ensure the load on the aft-most engine bearing is acceptable. Measurements can usually be obtained within thirty minutes, enabling shaft alignment to be evaluated at various loading conditions and machinery temperatures without significantly interfering with operations or production. The strain gauge alignment t

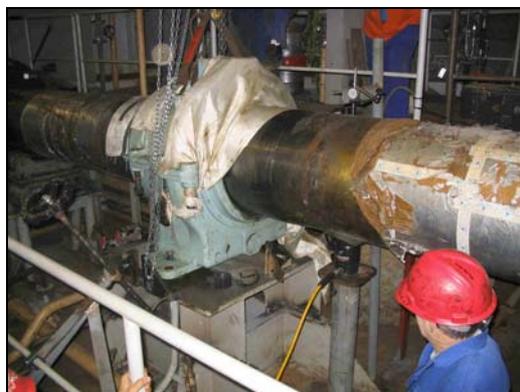
**Figure 2** Jack-Up Load Test on Lineshaft Bearing

The jack-up load method is used to measure the vertical load on the lineshaft bearings and the aft two main engine bearings [1]. The measured bearing loads are compared to the desired aligned loads computed from a theoretical model and to the allowable loads as specified by the manufacturer. The vessel is afloat and the shafting is supported by the bearings. Measurements are taken at various stages of assembly up to and including the fully assembled condition. A jack is placed near the bearing, the shaft is raised and lowered, and the load is measured at a number of positions. Figure 2 shows a jack-up load tests being conducted on a lineshaft bearing.

The vertical load on the bearing is estimated from a projection of the load displacement curve. The athwartships (horizontal) load can not be determined by this method. The jack-up load measurement on the two aft most crankshaft bearings requires a correction factor, which is commonly more than 50%, since the bearings are very close together. The aft most engine bearing is usually required to have a very low load, or even unloaded, in the cold aligned light-ship condition. Therefore, the jack-up load measurements on this bearing can be subject to significant errors. In addition, it is a cumbersome measurement to perform since the location is very confined. The number of jack-up load measurements can be reduced significantly if the strain gauge technique is employed.

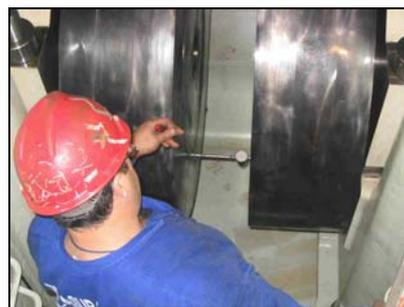
Figure 3 Crankshaft Web Deflection Measurements

Crankshaft web deflections are taken at the final stage of alignment. They are used to determine if the load on the crankshaft from the lineshaft is acceptable, and if the relative loading between crankshaft bearings are acceptable. Crankshaft web deflections should be as close to zero as possible in service condition (vessel loaded and warm) [2,3,4]. Special target values are applied during alignment to compensate for the affect of hull deflection on crankshaft bearing loads during loading of the vessel. These target values are developed based upon experience with different classes of vessels. In the case of 5S60MC-C for large bulk-carriers, the vertical crankshaft deflection target is between +0.06 mm and +0.22 mm. Figure 3 shows a crankshaft web deflection measurement being taken. Problems with crankshaft bearings have occurred when the aft most crankshaft bearing becomes unloaded when the engine is warm and the vessel is loaded. Typically the aft most engine bearing (on the thrust shaft) is aligned with little or no load in the cold static light ship condition. When the engine heats up and the vessel is loaded the load on this bearing increases and the load on the aft most crankshaft bearing decreases. The shear and bending moment combination at the thrust shaft flange, which provides an indication of the load on the aft most engine bearing, is specified by the engine manufacturer. To ensure a proper alignment is achieved within tolerance, strain gauge alignment measurements are used to directly measure this shear and bending moment.

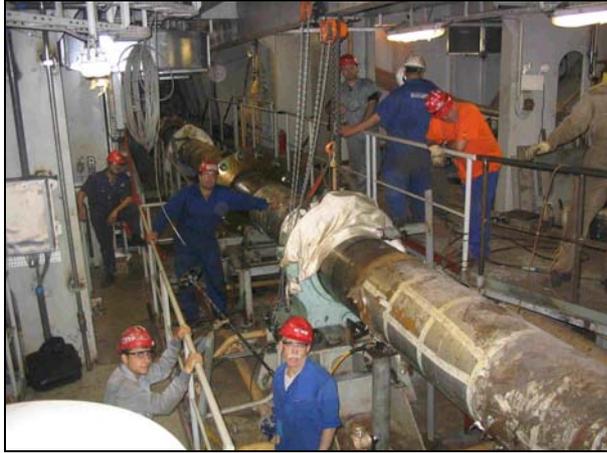
Figure 6 Jack Up Load Tests on Lineshaft

The strain gauge alignment technique was employed after the engine flywheel flange was bolted to the forward lineshaft flange. Initially, the two lineshaft bearings were lowered 1.2 mm in an attempt to achieve the prescribed bearing loads on the forward sterntube and aft line shaft bearings. In this position, the forward lineshaft bearing load was about 84 kN lower than the prescribed loading, and the BM and Shear combination on the thrust shaft flange was out of the acceptable range (see Table 4 and Figure 8). This misalignment could only be corrected by movement of the engine, primarily by lifting the forward end of the engine. The forward end of the engine was then raised about 14 mm to achieve acceptable crankshaft web deflections. The aft lineshaft bearing was also raised 1.6mm. Figures 6 and 7 provide a view of the lineshaft during the alignment and inside the crankcase, respectively.

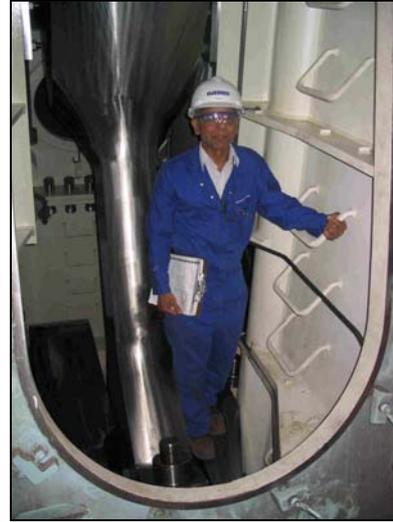
Figure 7 Standing on Crankshaft Web

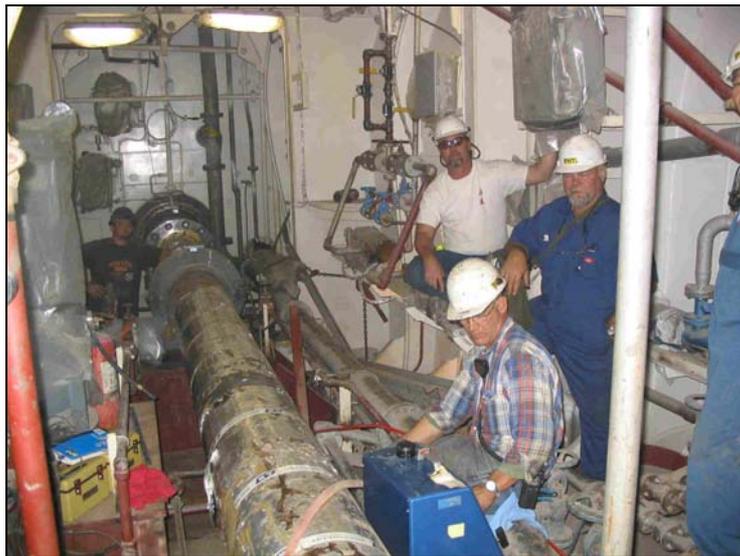
**Figure 11** Alignment Measurements on Lineshaft: MV Jean Anne

Prior to the strain gauge alignment, the shafting was aligned according to gap and sag and jack-up load methods. The strain gauge alignment was conducted with the lineshaft bearings and main engine on jacking screws and with the engine flywheel bolted to the forward lineshaft flange. Warm alignment measurements were conducted immediately after sea trials. The cranks shaft web deflections were measured at the same time as the strain gauge alignment measurements. Table 8 lists the measured bearing loads for both the cold and warm conditions. Table 9 provides the estimated bearing offsets based upon the strain gauge alignment measurements and the finite element model analysis. The Figure 11 presents the measured shear and bending moment at the thrust shaft flange. Jack-up load tests were also conducted on the lineshaft bearings to provide an independent check of the strain gauge alignment model. Figure 12 presents the results, which indicate excellent agreement with the strain gauge alignment results. The strain gauge measurements indicated that the bearings were aligned to their prescribed vertical positions, and were straight-aligned athwartships to within 0.25 mm and to less than 30% of the vertical bearing load, which is considered acceptable. The bending moment and shear measured at the thrust shaft flange was within the acceptable range for both the cold and warm condition. The maximum lineshaft bending stress measured was 11 MPa, which is considerably lower than the maximum allowable stress of 41 MPa. The bearing temperatures and shafting vibrations were satisfactory throughout the sea trials, and since the vessel entered service in the spring of 2005. Figure 13 shows alignment measurements being taken.
